Manhole Inspection Summary

Manhole # S37GG1021MH

Insp Date: **1/10/07 4:32 PM**

Location Address: **3983 FRISBY ST**

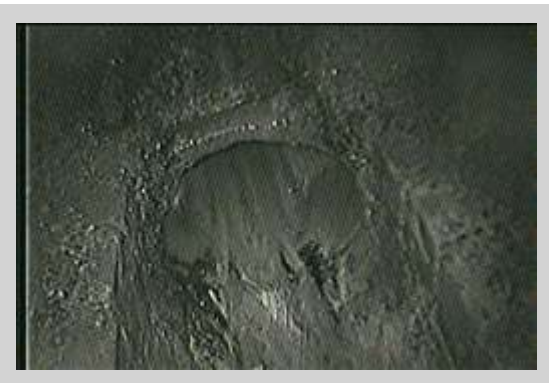
8 in. Circular Gravity Sewer Pipe In @ 7 O'Clock

Rod and Bar (Angled)

Infiltration: **None** Pipe Seal Cond: **Unknown**
